Existing condition of the substructure (piers)

Ranges from poor to fair

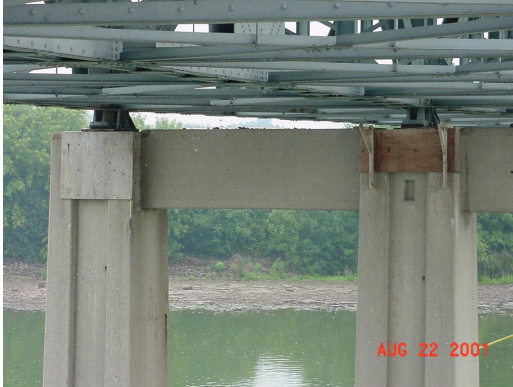
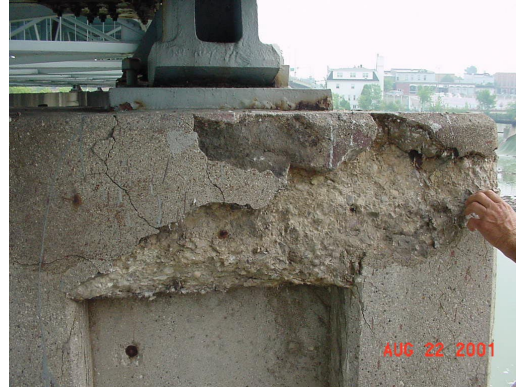
Pictures of the bridge's pier caps show previous repairs and deteriorating concrete that can be pulled off by hand.

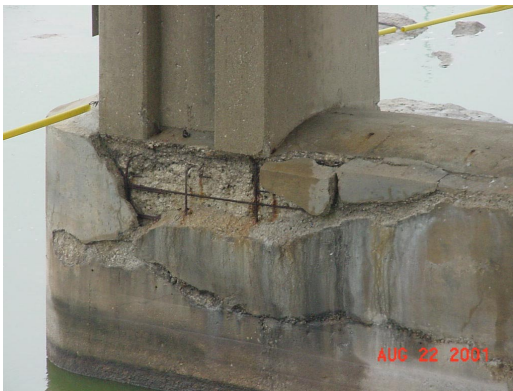
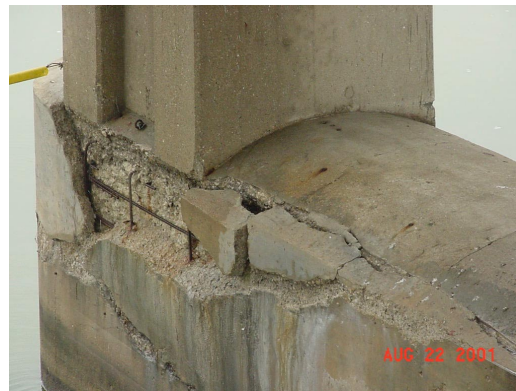
The pictures above show two different angles of a previous repair/patch failing on the same pier. The pictures below also show deteriorated concrete with exposed (rusting) steel reinforcement.
